## To Change BMW C1 Stand “Weak Link”

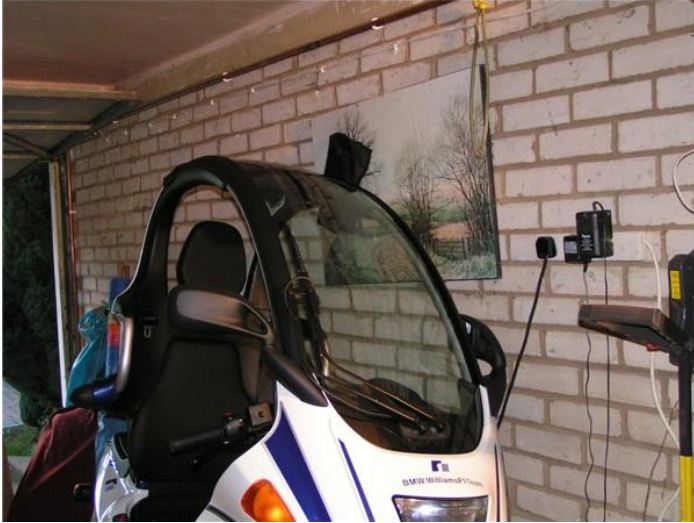
First raise stand manually and, with a pad to protect your paintwork, lean the C1 against a wall

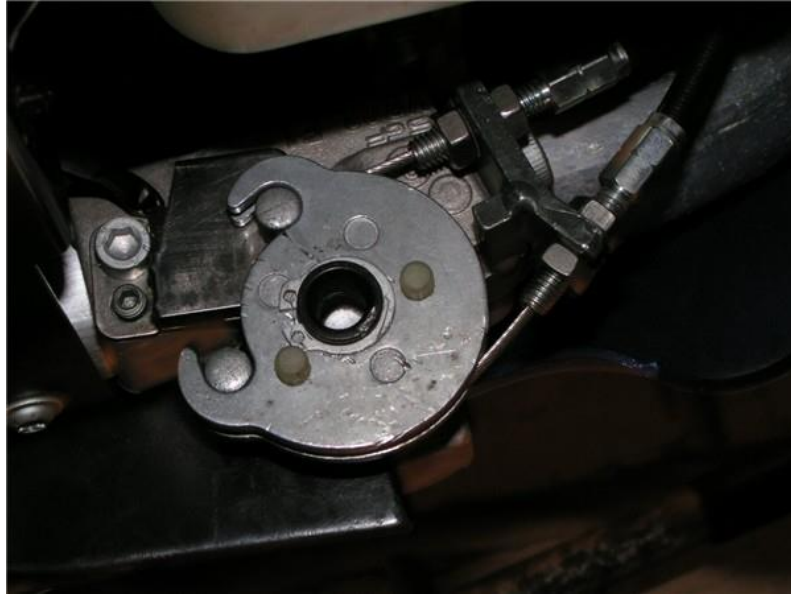
Then raise the stand manually and look underneath the C1. Near the stand look for this

part with the cables attached. Just to check that it is the weak link broken and not a cable, move the raise lower lever to and fro and you should see this assembly moving. If it does, good – it is just the weak link broken. If not then, well its grief apparently.

Assuming it is moving, remove the circlip you can see. Then undo the cable adjuster nuts right off to give you max slack. Remove the cables from the mechanism. Mark the face of the metal quadrant and with a bit of a wiggle (and perhaps some gentle levering with a screwdriver) the quadrant will slide off.

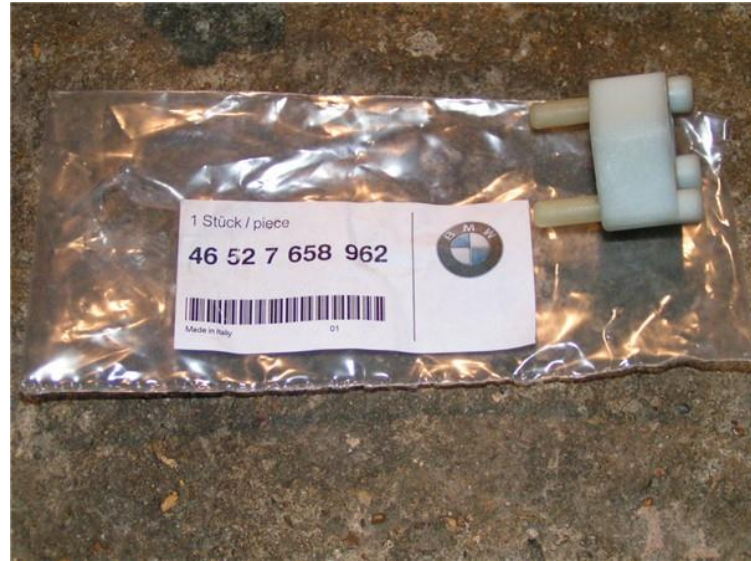
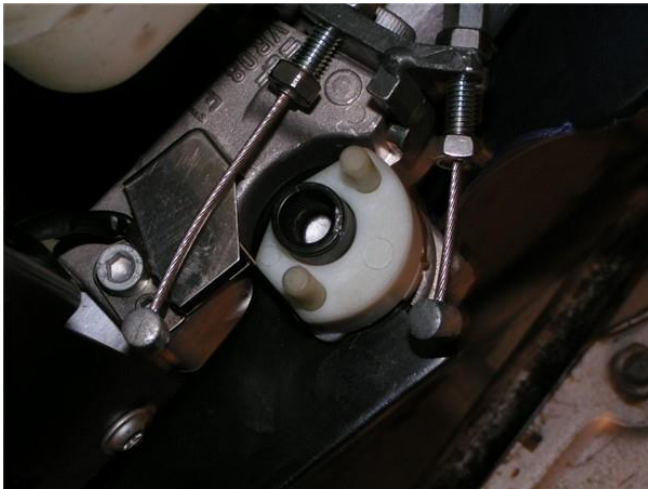
Here is a pic of the replacement part you need, and the BMW number

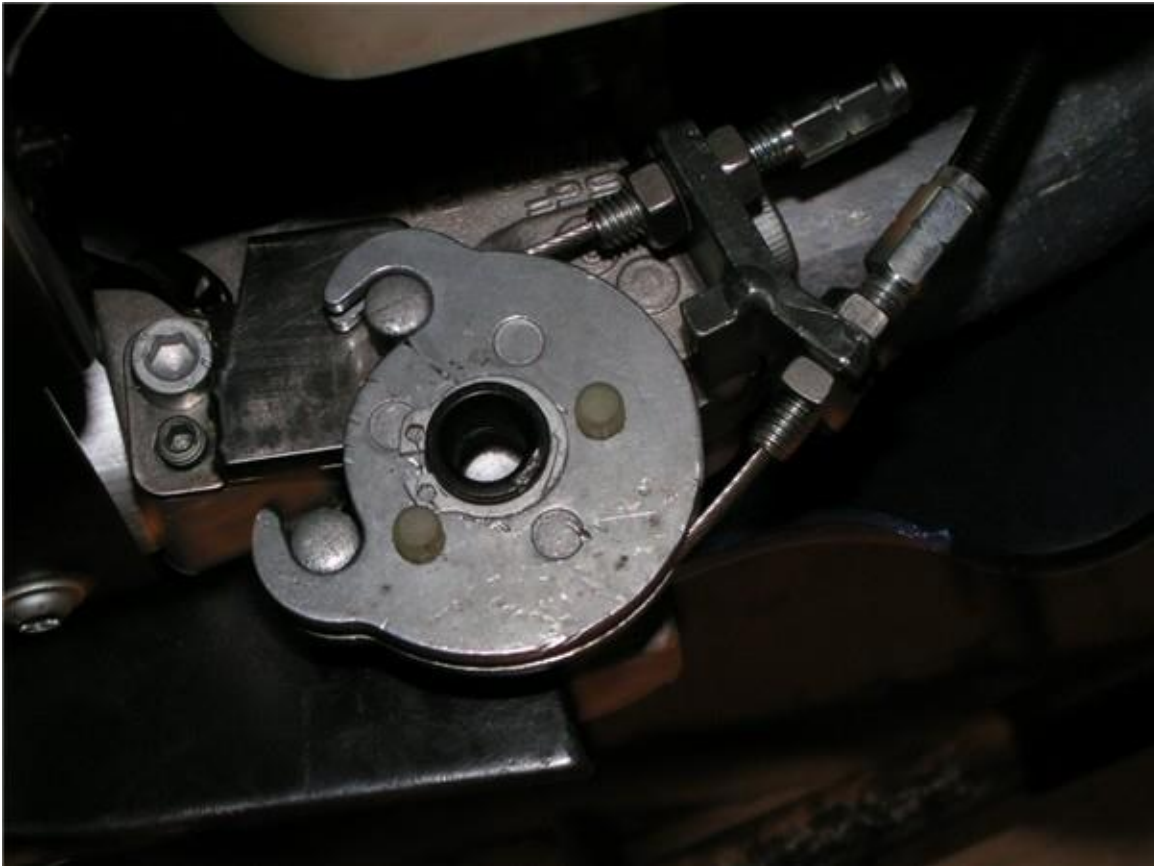
Now – ready to replace it all. First you must mate the plastic weak link to the quadrant (noting your earlier mark to note the front of the quadrant). A gentle tap on the floor will be required to push the pins of the weak link into the quadrant. Then install the unit onto the shaft again and slide it along (careful with the switch blade again) until it matches up with the stand holes and notches. A gentle tap may be required to finally seat it before replacing the circlip. Now, some manipulation is required to reinstall the cables – using a combination of moving the raise/lower lever inside the “cabin”. I found it easiest to fit the left cable (as shown above) , then insert the lead stop bit of the right cable and finally slotting in the adjuster. Providing both adjusters are fully slackened you won’t have any bother. Both cables must then be adjusted to remove the slack. Hopefully then, you are back to looking like this

But this time your stand will move – well, mine did!

Behind the metal quadrant you will see the offending plastic part with the 2 broken pins (this pic shows a new one in place but you get the idea) Remove the plastic part by levering with a screwdriver gently (be careful, there is a switch "blade" that slides on the plastic part – don't damage it). Then remove the 2 broken pins left poking out of the metal quadrant
